OPERATION PLUMBBOB

Project 3.3

EVALUATION OF BURIED CORRUGATED-STEEL ARCH
STRUCTURES AND ASSOCIATED COMPONENTS

OPERATION PLUMBBO3—PROJECT 3.3

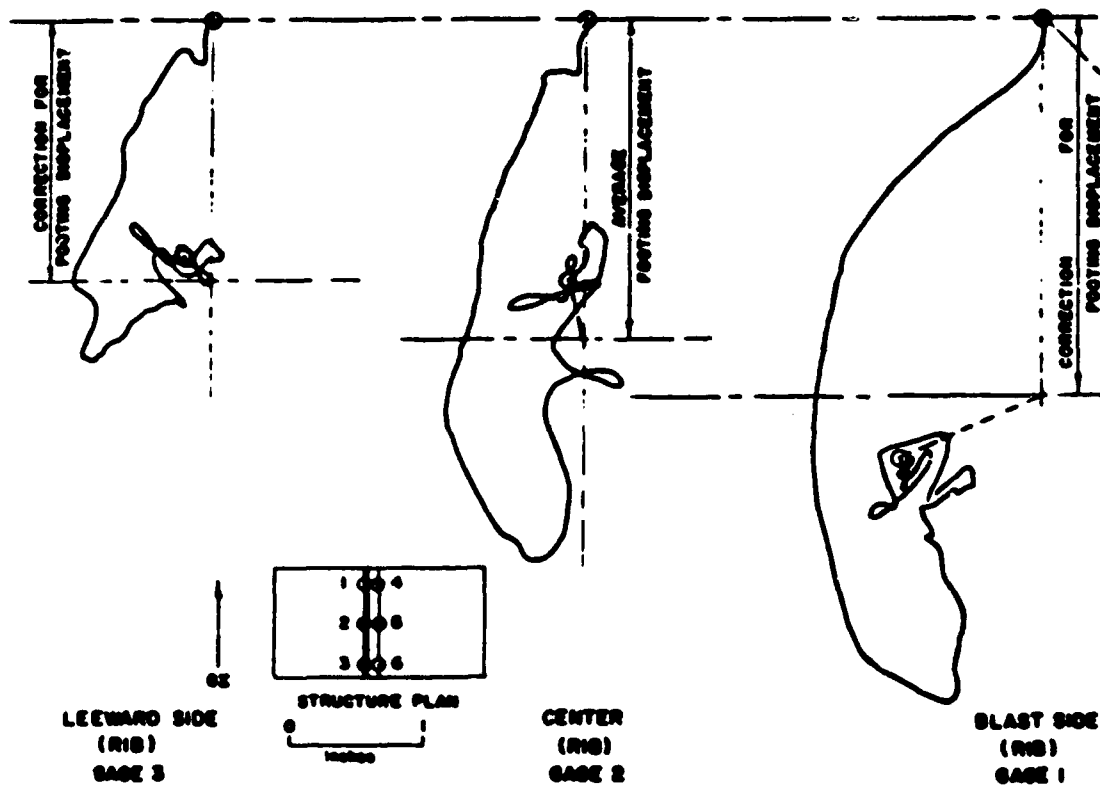
Figure 2.28 Deflection records at rib, Structure 3.3a.

The arch-deflection data given in Table 2.4 has been taken from scratch-gage records. Full-scale scratch-gage traces are given in Figures 2.28 through 2.32.

are shown in Figures 2.28 through 2.32. A horizontal and a vertical line are drawn through the initial point. Another horizontal line is drawn a distance below the initial scribe point equal to the correction for residual footing displacement. The heavy dashed line indicates approximately the residual deflection of the point on the arch due only to arch flexure, arch compression, and arch-joint slippage.

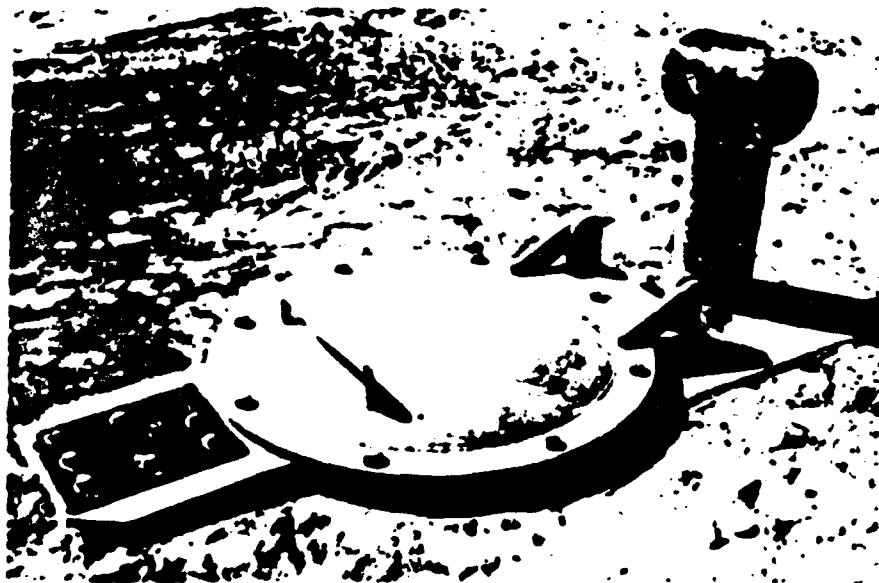
The peak overpressure observed at earth surface was 60 psi. The duration of the positive phase was 345 msec. The peak internal pressures in plenum were 0.32 psi (positive) and 1.20 psi (negative).

In interpreting the results tabulated, it should be kept in mind that the plenum might be larger or smaller than practical designs of expansion chambers to be used in working shelters. The 0.32-psi pressure rise in a 215-ft³ expansion chamber would represent a net airflow of approximately 6 ft³. The capabilities of the blast closure valve in a particular situation will depend upon the expansion-chamber design. Inasmuch as the 12,500 ft³ of the shelter chamber proper is too large for a significant pressure rise to occur at these flow rates, the apparent leakage of the device need be investigated only as it affects the integrity of the collective protective filters, and when a plenum is used. Because of the long duration and poor seating of the valve compo-

A comprehensive study of corrosion of various parts of this unit was made in salt air (Reference 32) from a windborne spray. The results indicated that the mild steel parts should be replaced with more durable metal or treated to avoid corrosion. Neoprene foam rubber should be used as the gasket material. In the tests during Operation Plumbbob, the use of a more durable and softer sealing gasket might have materially reduced air leakage in either direction.

Figure 3.2 Blast closure valve installed in test plenum.

The valve should be considered satisfactory only for the maximum pressure conditions under which tested.

Additional performance data should be obtained by extensive tests over a wide pressure range in a suitable blast-simulating device. Further, particular attention should be given to the negative phase in any design situation in which it is expected that the pressure will exceed the design tolerance of the collective protective filters. It appears impracticable to redesign this valve for protection during the negative phase, but redesign of the gasket and substitution of a better sealing material might eliminate most of the leakage.

Further engineering development of this valve is warranted and recommended.

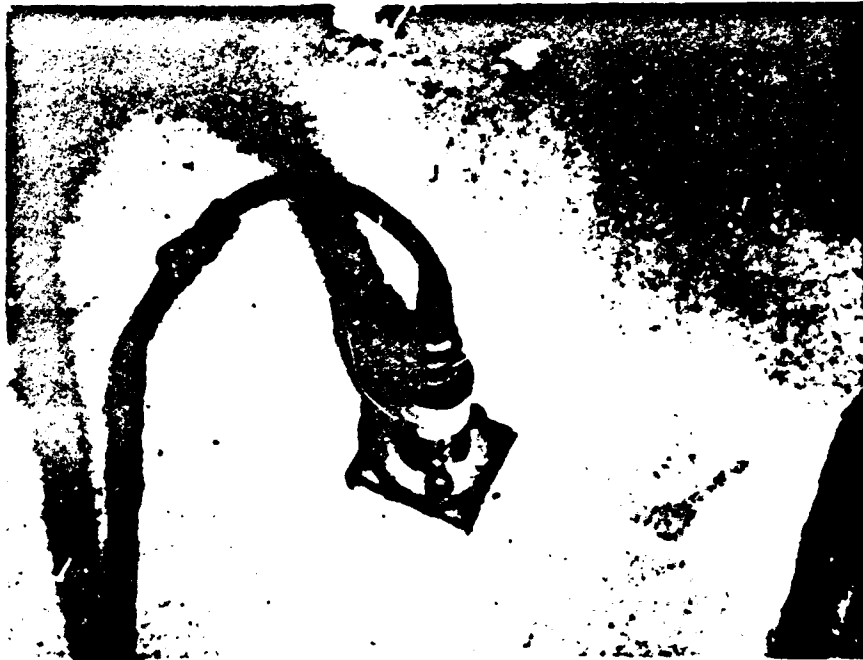
Figure B.11 Electronic accelerometer in place.

It was concluded that, because of a good electronic record with no apparent values on all gages, a value of less than 3 g had been observed. The accelerometers utilized were of 0-to-100 g range calibrated to 50 g. A small-range gage would have given a more significant record, had it been known that accelerations of such small magnitudes would have been experienced.
